**123 Main Street  
Anytown, Anystate 12345**

**Prepared By:** Structural Engineers dot Com, Inc.  
120 Perquimans Court  
Hertford, NC 27944

**Date:** December 10, 2025

**Overview:**

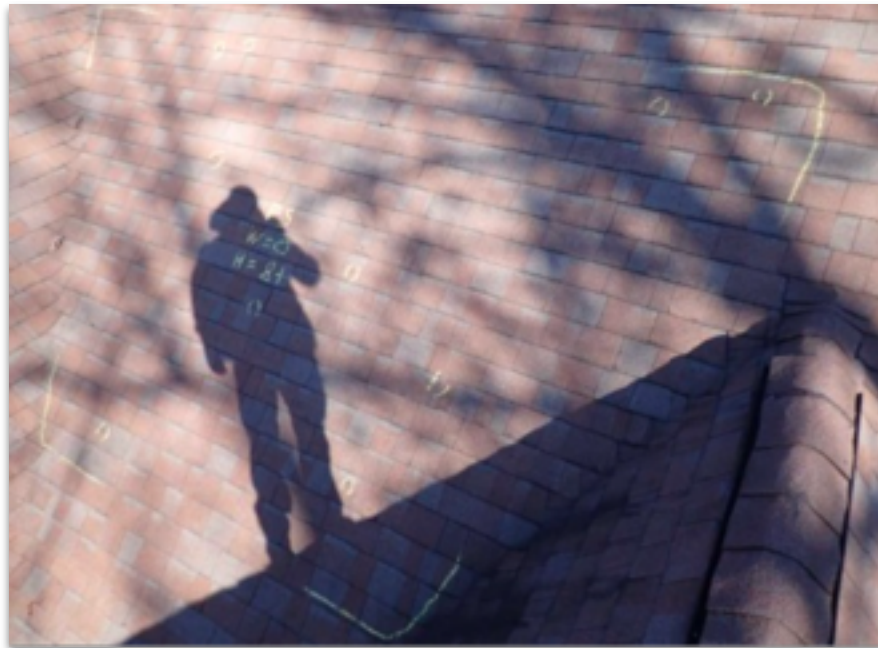
**Photo 1: Front slope test square overview**

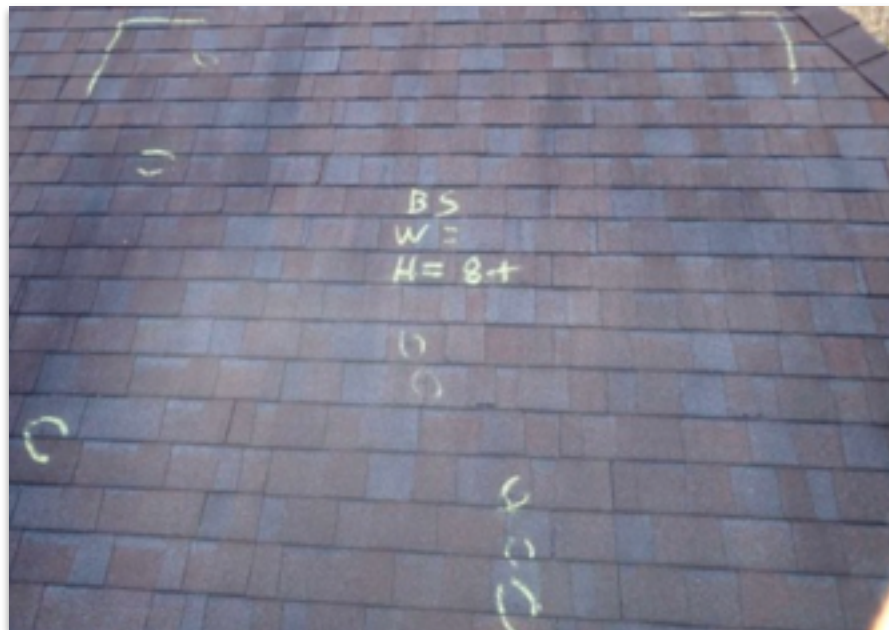
**Photo 2: Back slope test square overview**

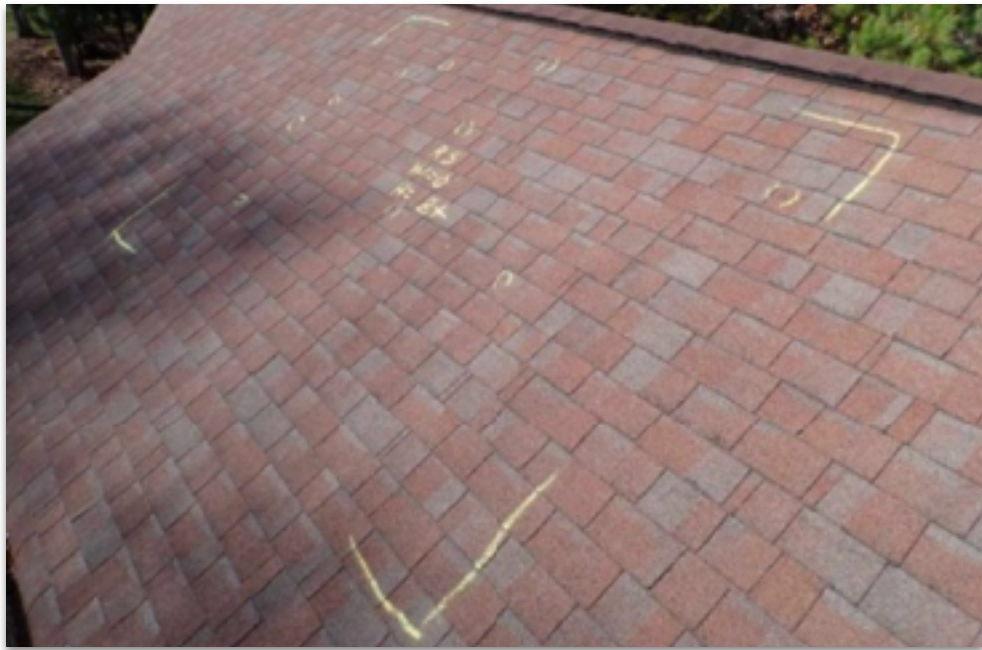
**Photo 3: Right slope test square overview**

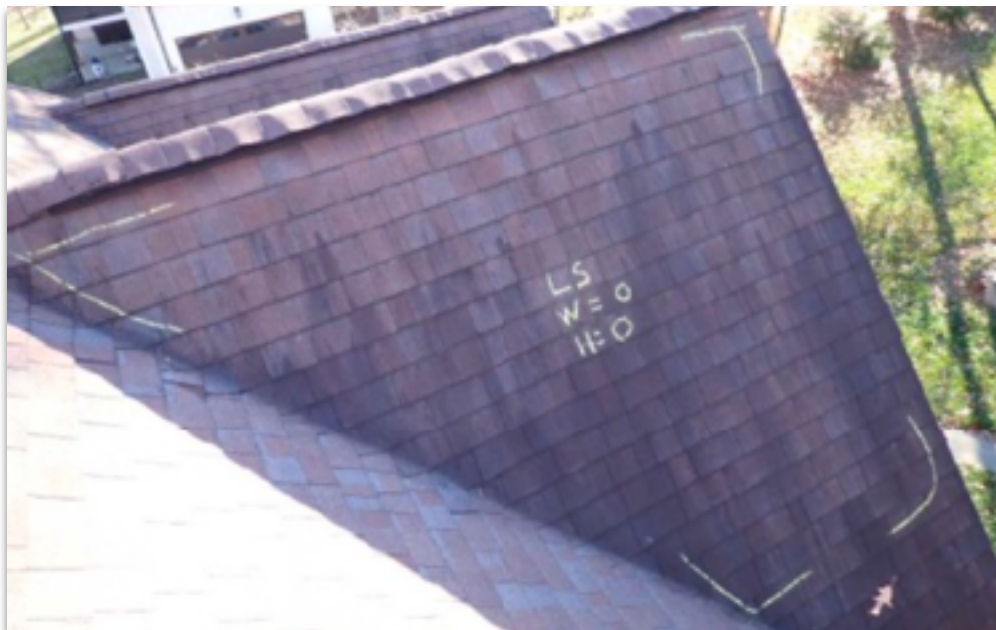
**Photo 4: Left slope test square overview**

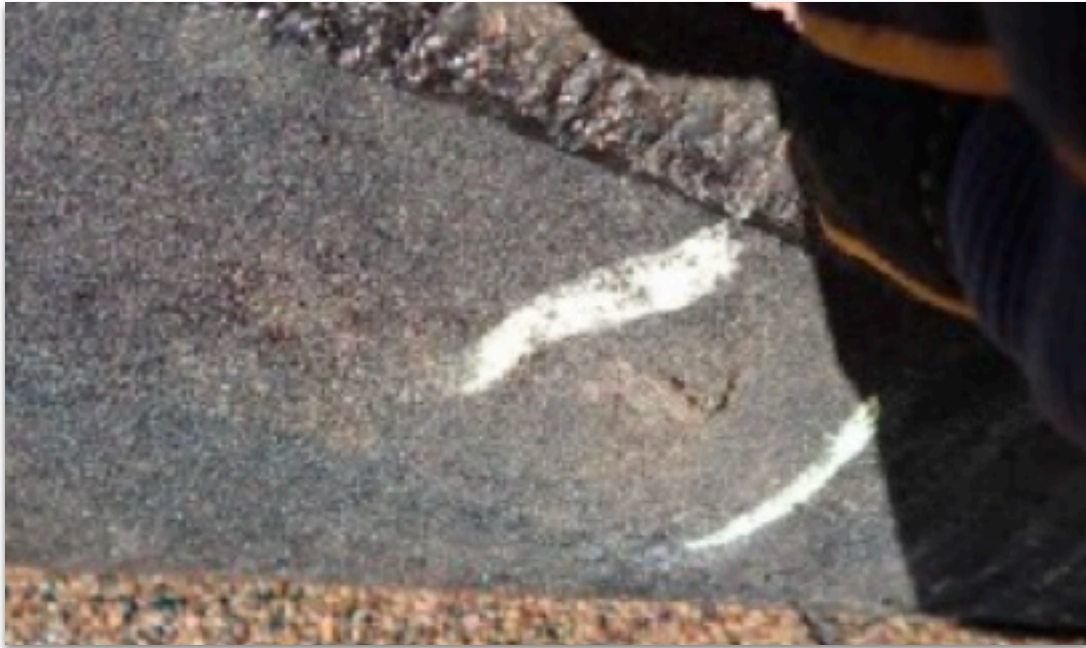
**Photo 5: Fracture on back of shingle**

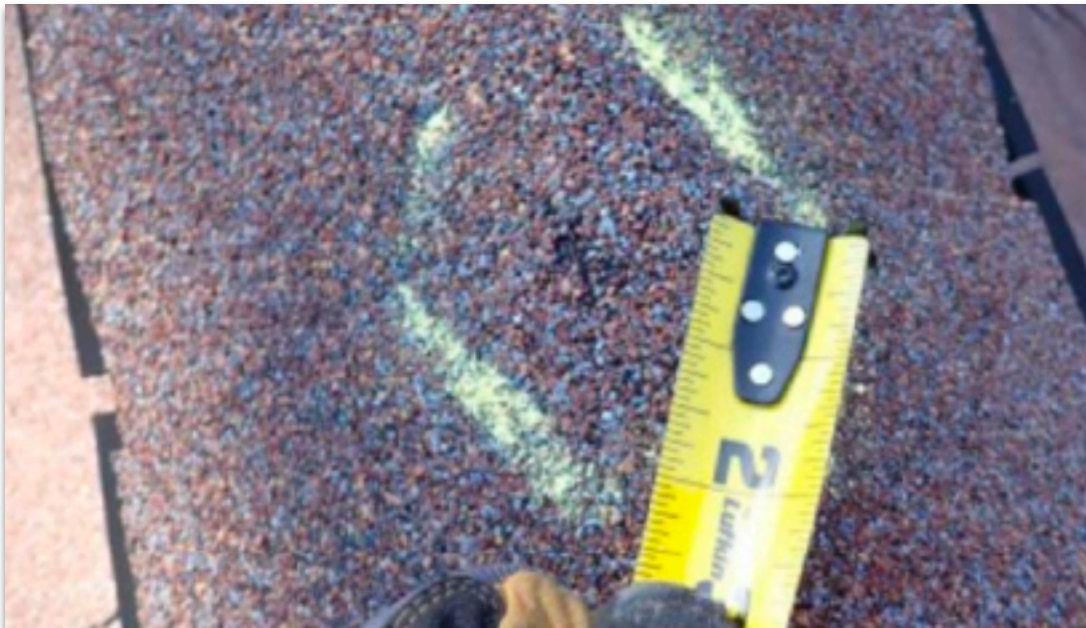
**Photo 6: Damage close-up photo**

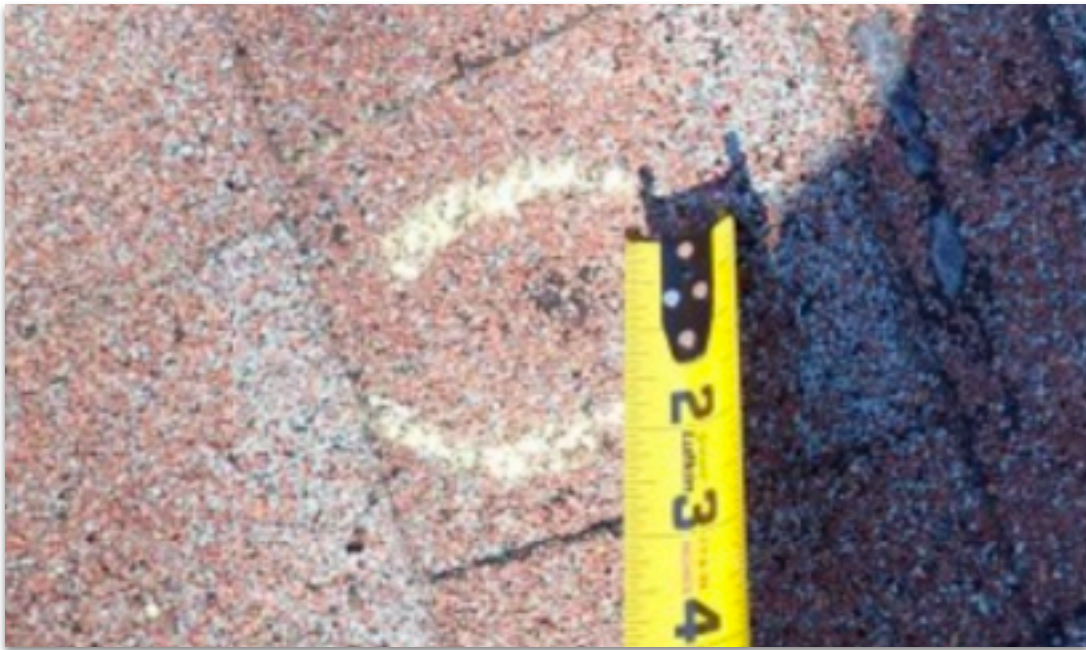
**Photo 7: Damage close-up photo**

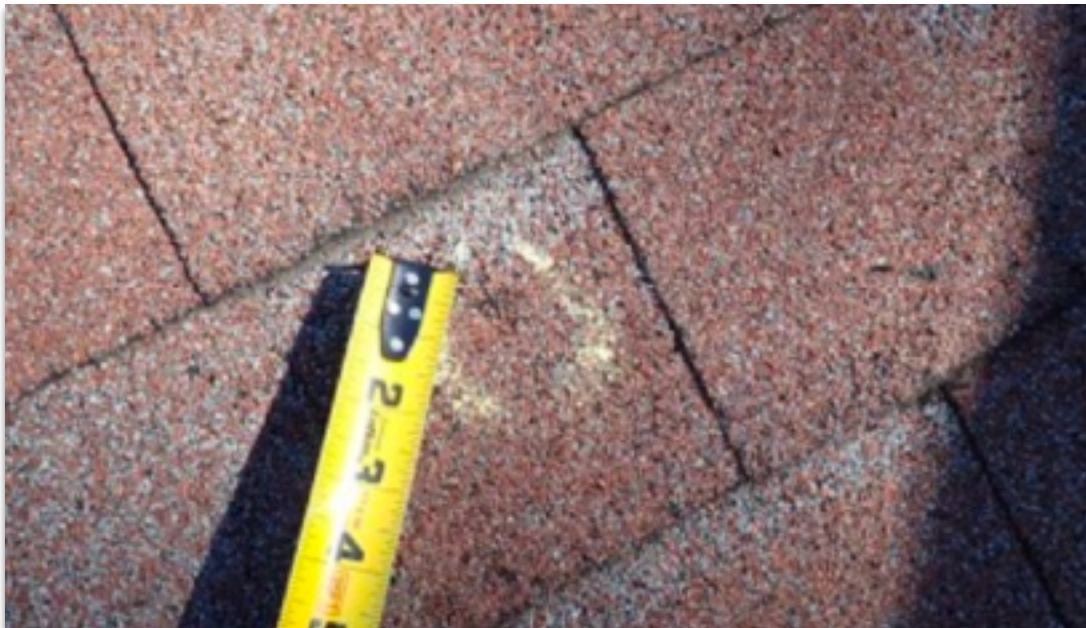
**Photo 8: Damage close-up photo**

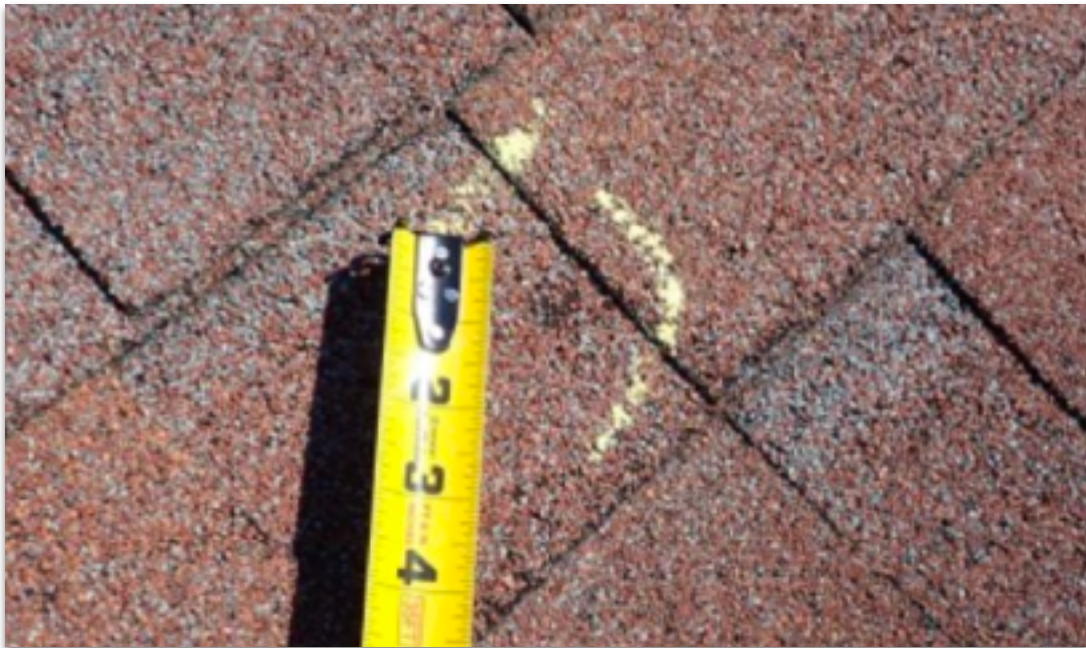
**Photo 9: Damage close-up photo**

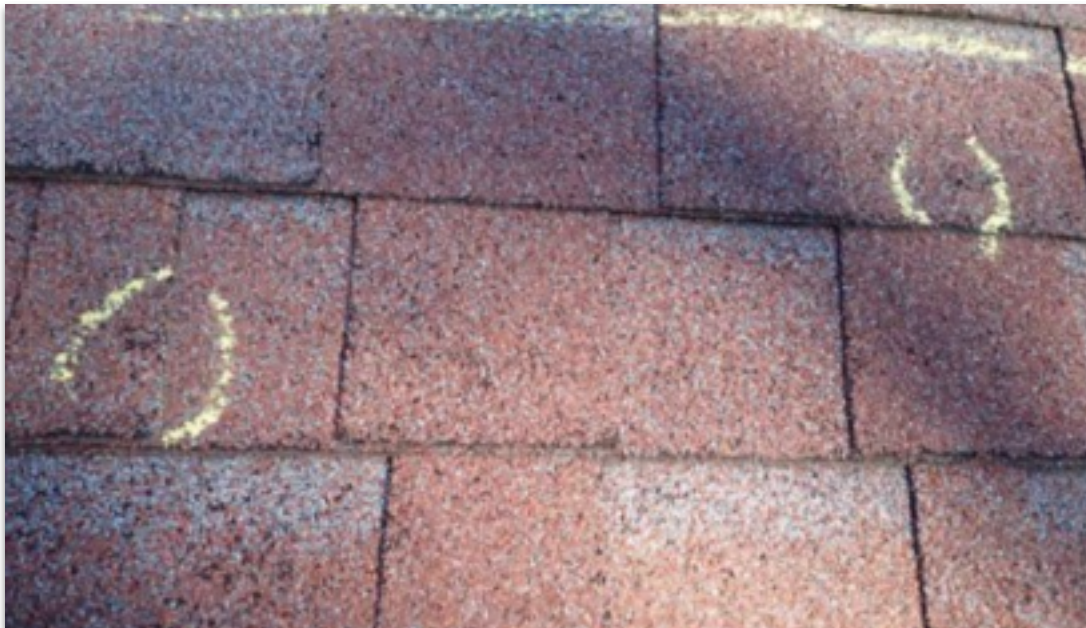
**Photo 10: Damage close-up photo**

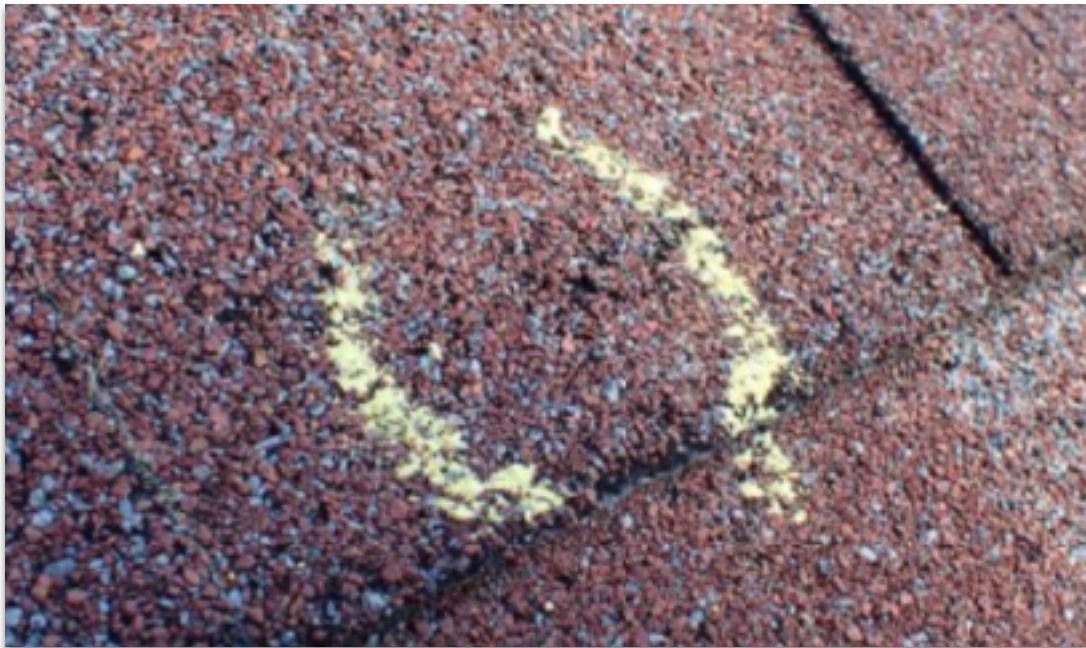
**Photo 11: Damage close-up photo**

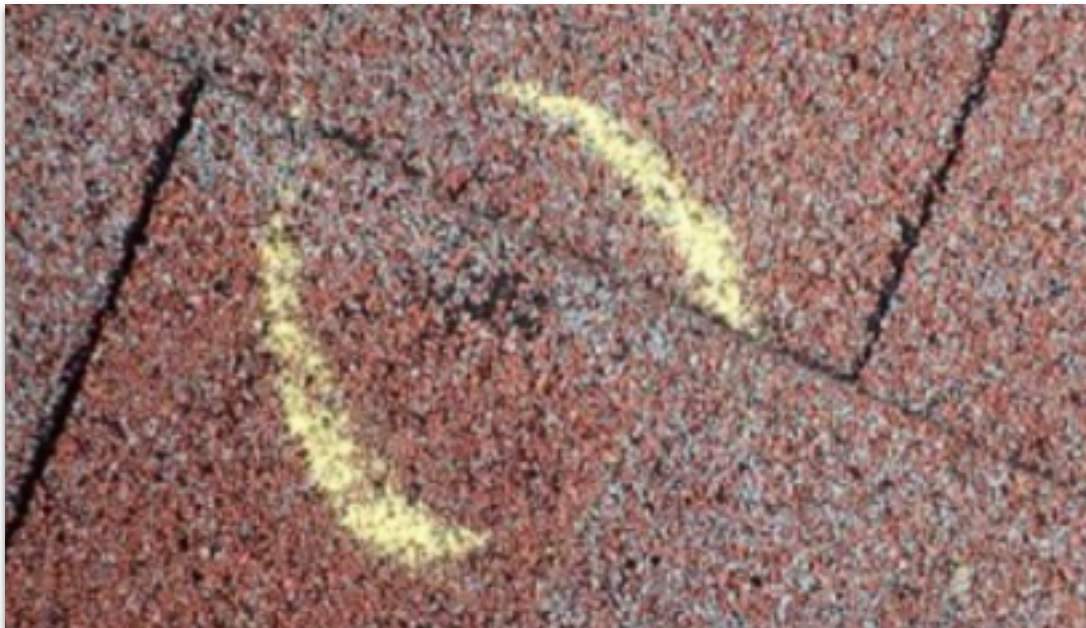
**Photo 12: Damage close-up photo**

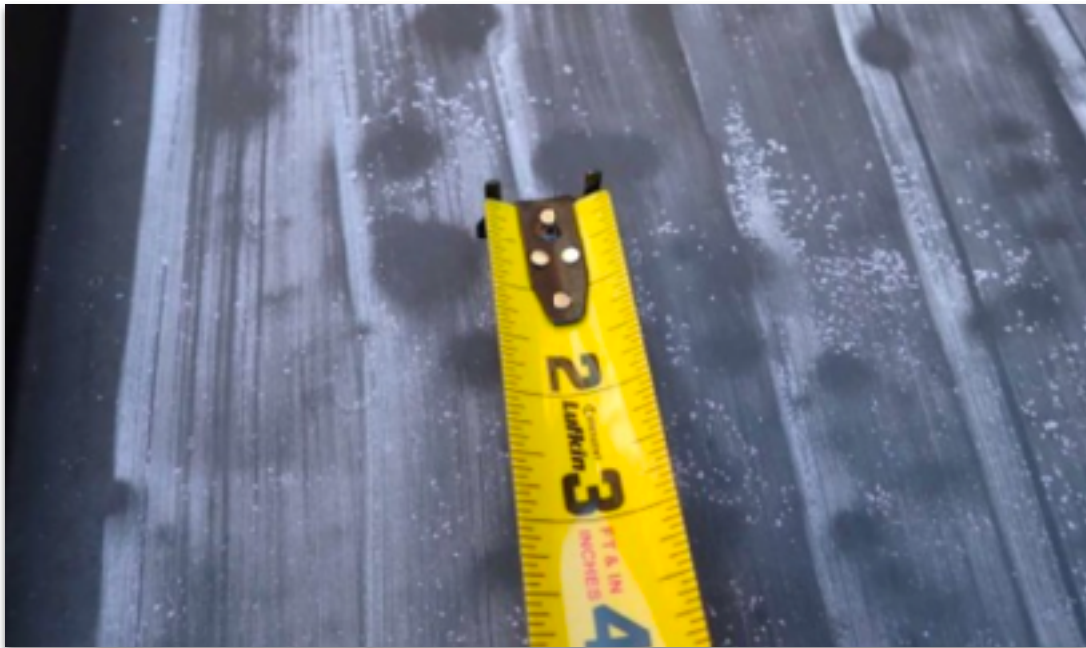
Additionally, collateral damage was found on a roof vent, metal roofing on the front of the home, and a downspout on the front of the home with dents measured between 3/4" and 1.25" in diameter (Photos 13-16). Multiple areas with stains indicating water intrusion were also noticed on ceilings around the interior of the home.

**Photo 13: Dents to metal roof**

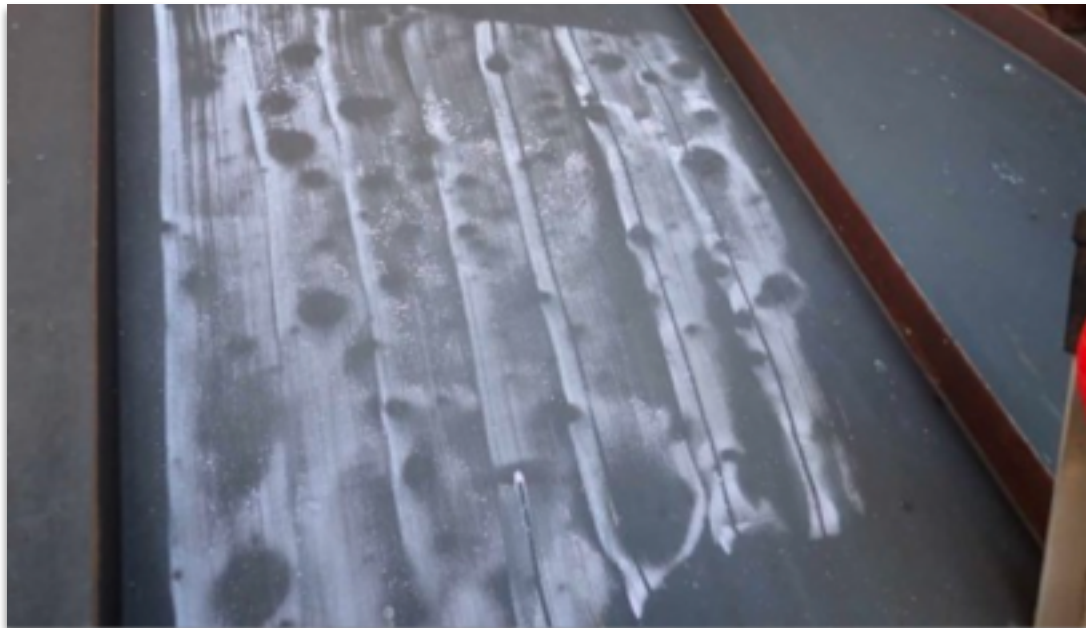
**Photo 14: Dents to metal roof**

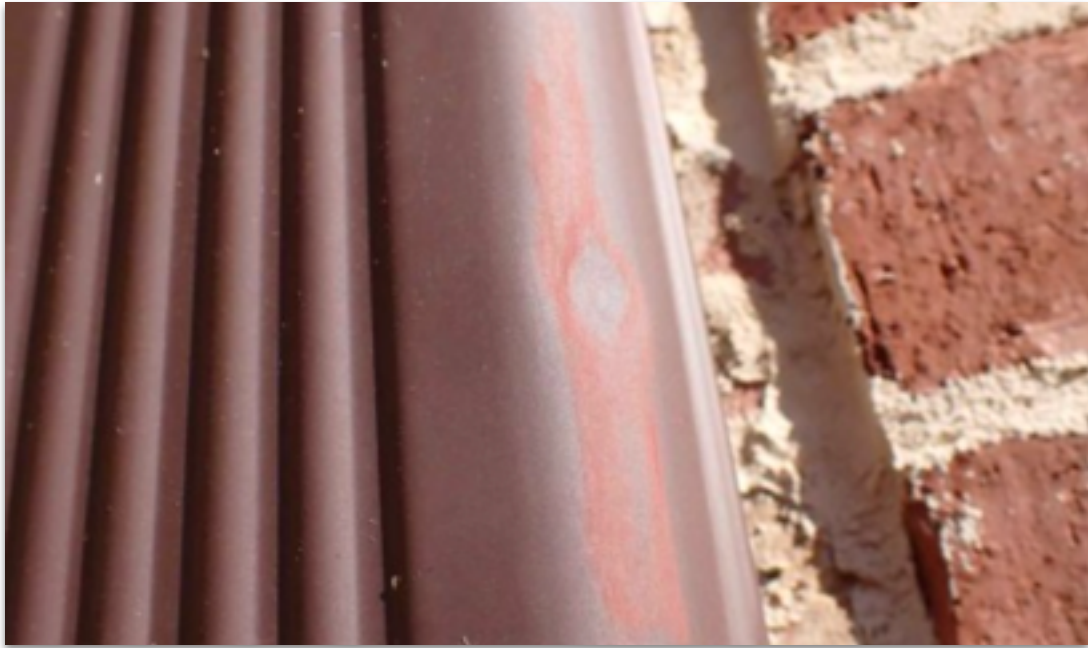
**Photo 15: Dent to gutter**

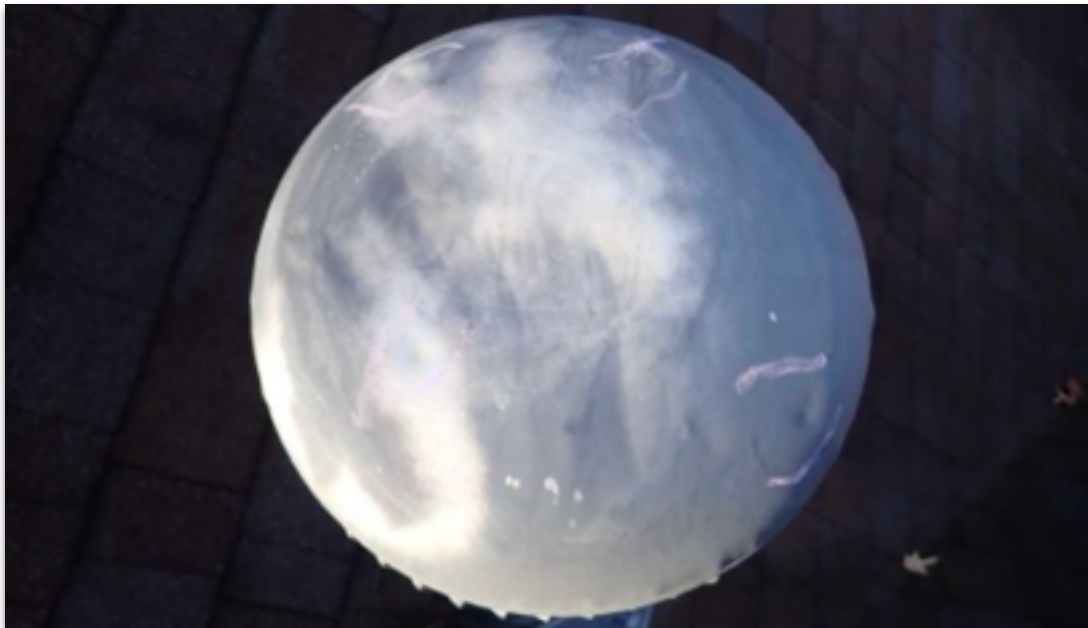
**Photo 16: Dents in vent on roof**

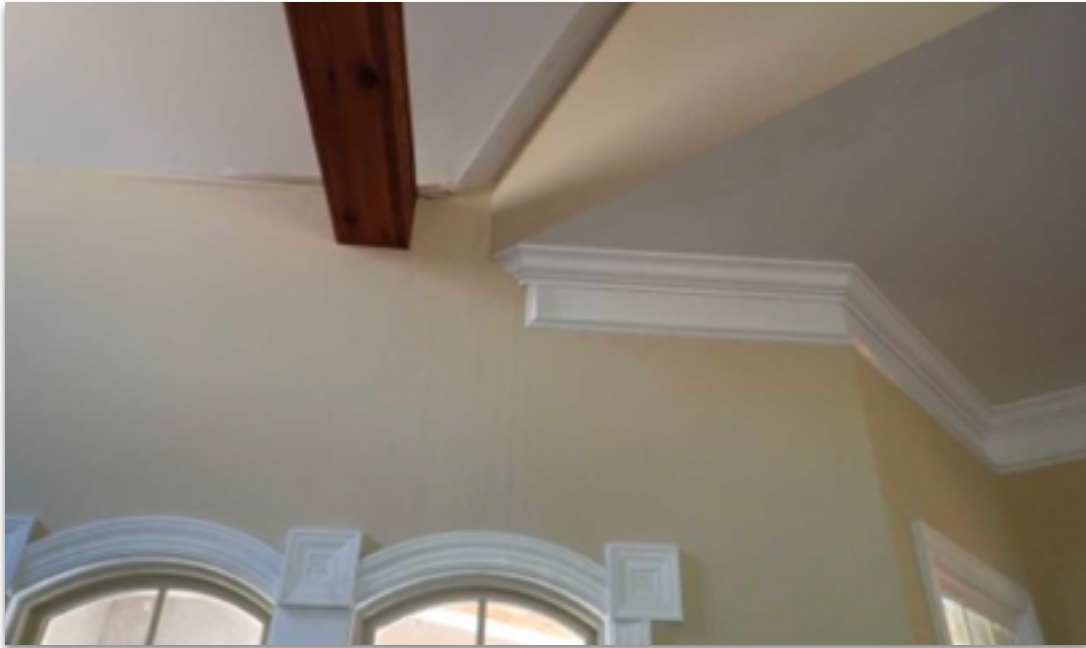
**Photo 17: Interior water stains**

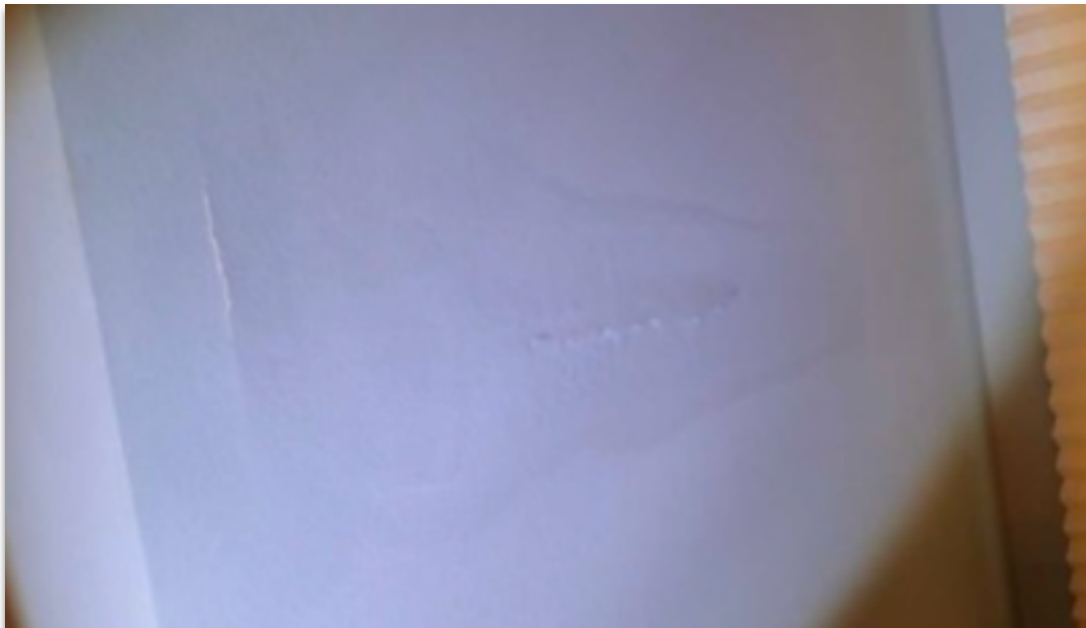
**Photo 18: Interior water stains**

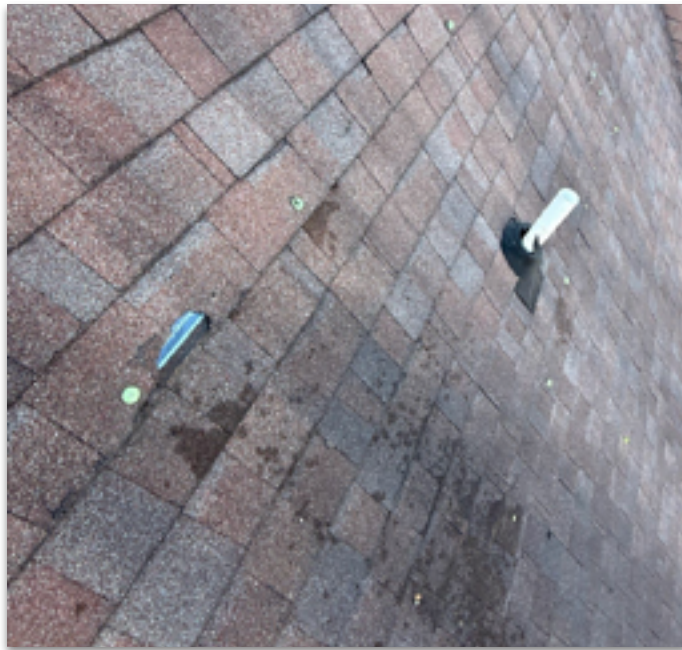
**Photo 19: Damaged shingles on back of home**

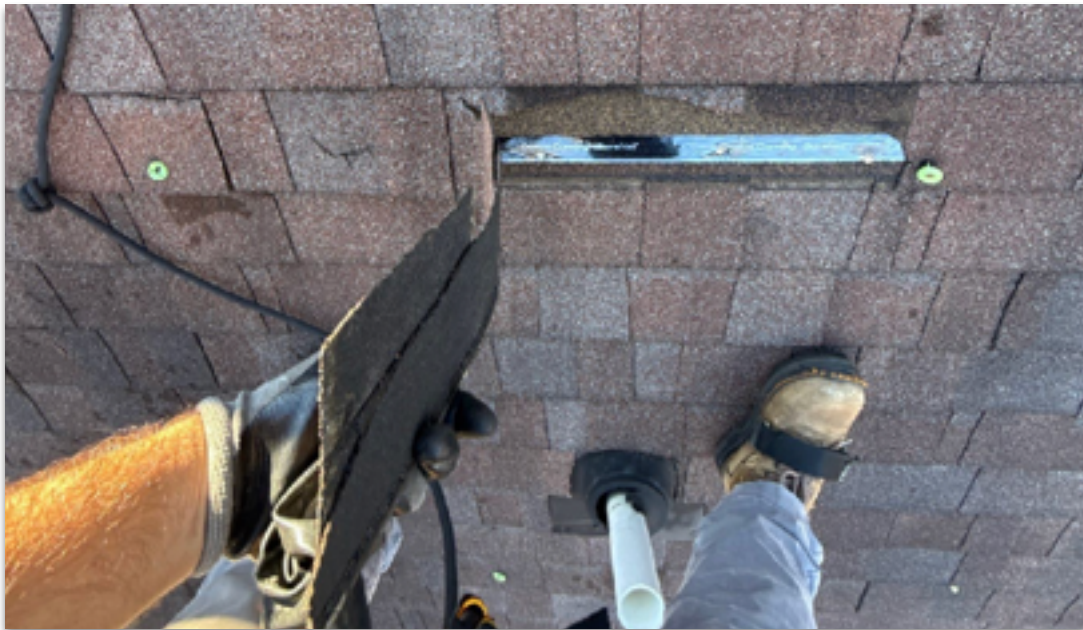
Regarding the interior water damage, while a damaged vent boot and torn shingles in valleys likely also played a role, Structural Engineers dot Com believes that water intrusion did at least partially result from torn shingles on the back side of the home (Photos 19-20); however, we do not believe that the 5/15/2024 storm that caused the hail damage contained high enough winds to create the level of shingle damage seen. The 5/15/2024 storm showed a peak gust of 23 MPH at the Charlotte-Monroe Executive Airport Weather Underground station (Weather Data 2), which would be unlikely to cause the roof damage seen. Reviewing the NOAA Storm Events Database for wind events in Union County, NC between 1/1/2024 and 5/15/2024 (Weather Data 4), it appears that this roof damage most likely occurred on 5/8/2024, when multiple 50 knot gusts were reported, including one in Waxhaw. Although this storm passed over the entire home, the cells appear to have gotten strongest once they were to the southeast of the home, potentially allowing a damaging gust to impact only the backside of the property.

**Photo 20: Torn shingles on back of home**
